Analytic Report

BioEraser System

Non-chemical water treatment

PowerPack Staticon BioEraser System – Analytic Report

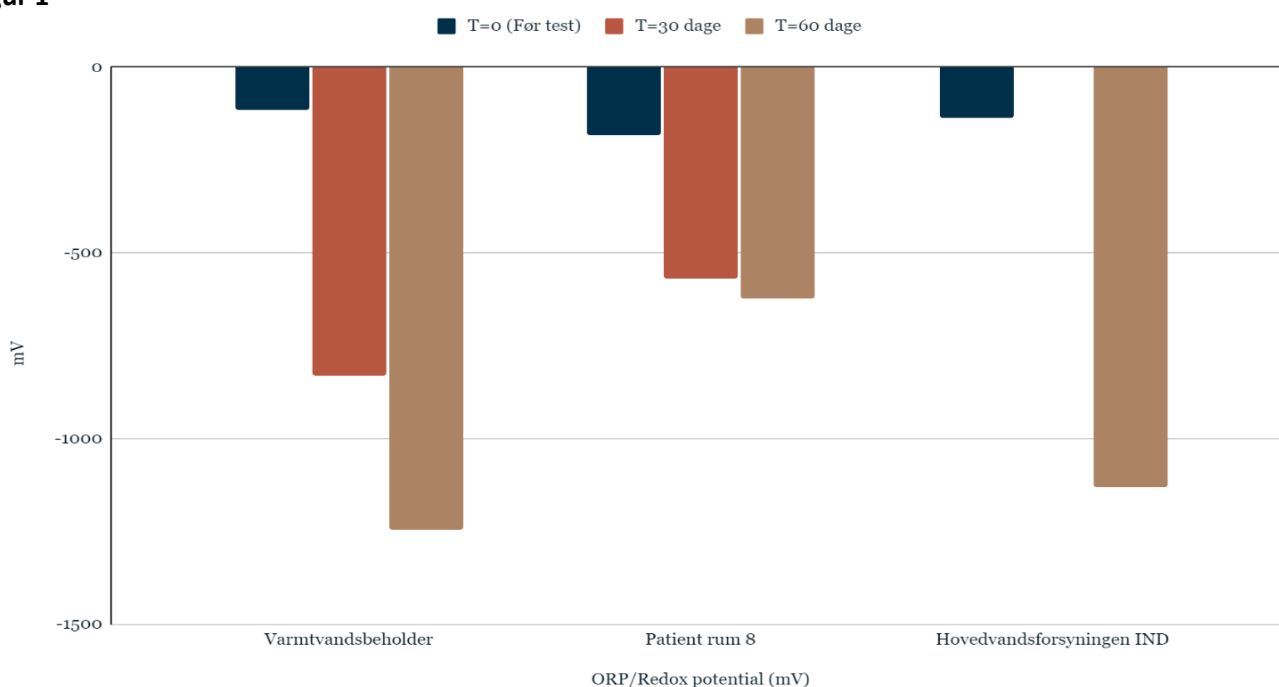
Figur 1

The redox potential increased negatively throughout the experiment as shown in Table 1 and Figure 1:

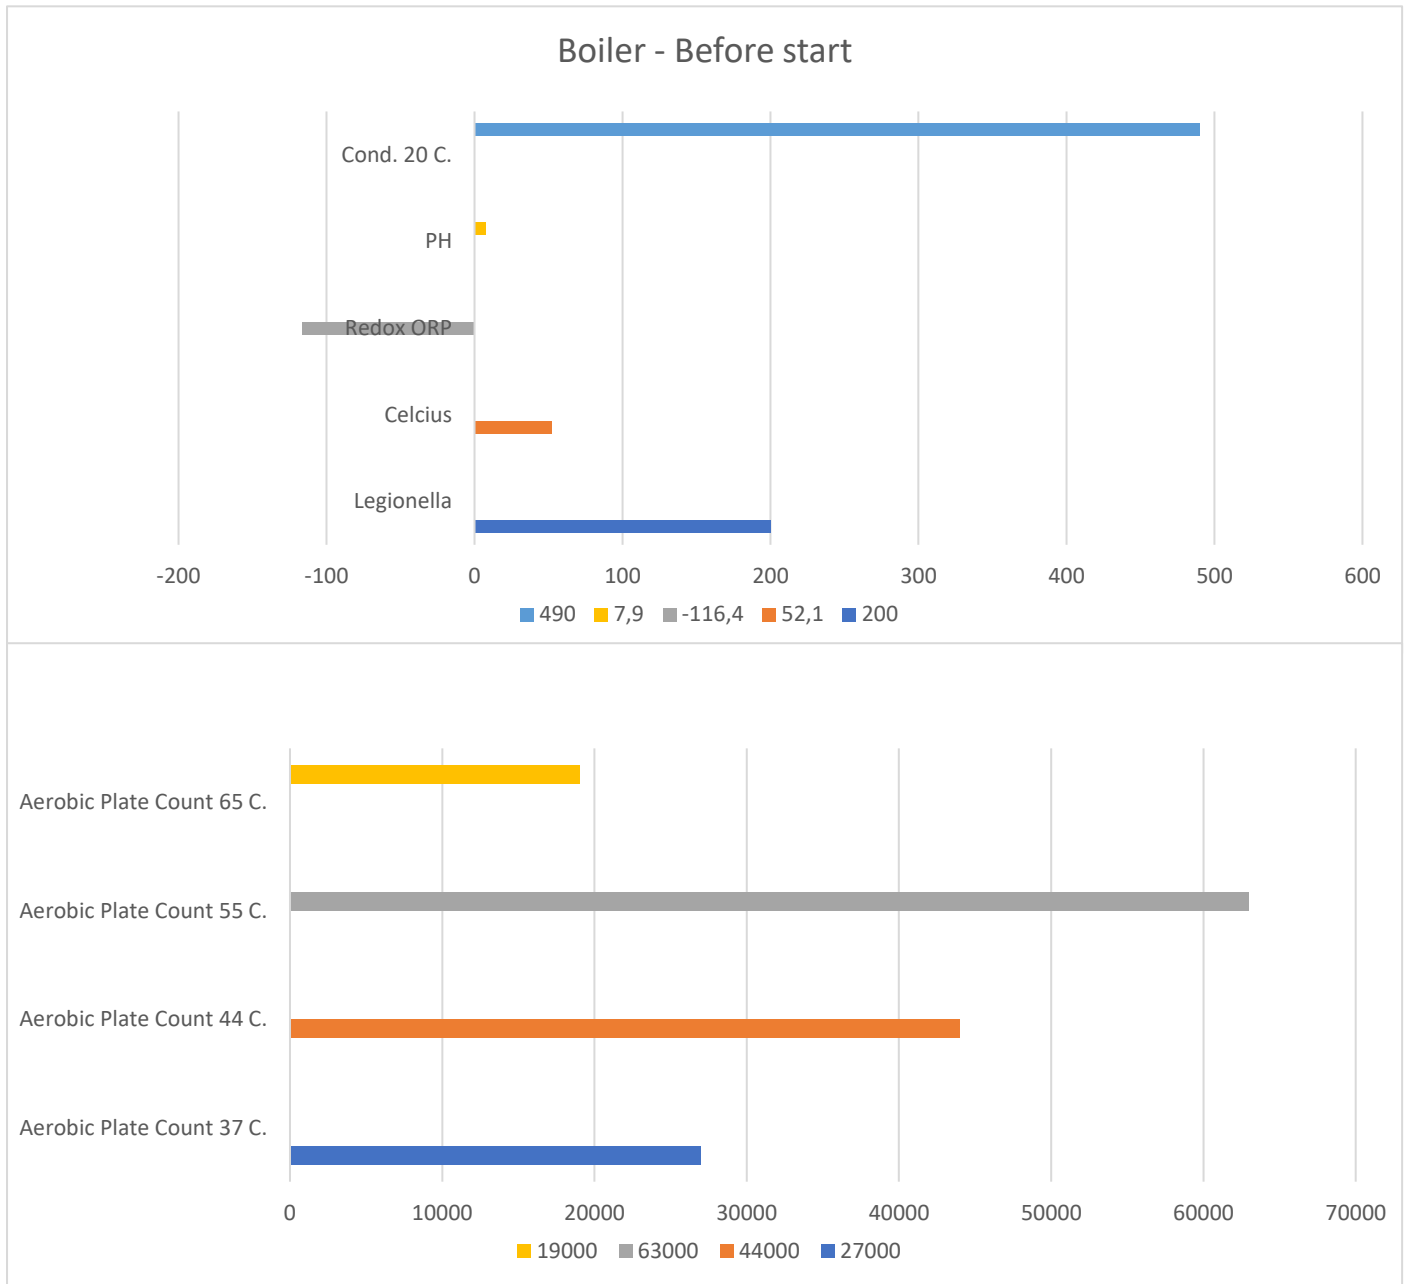
(Eurofin's Annex 3)

The last test, is from the hot water tank (before starting the test period)

Here you can also see germs (the Aerobic Plate Count) and Legionella.

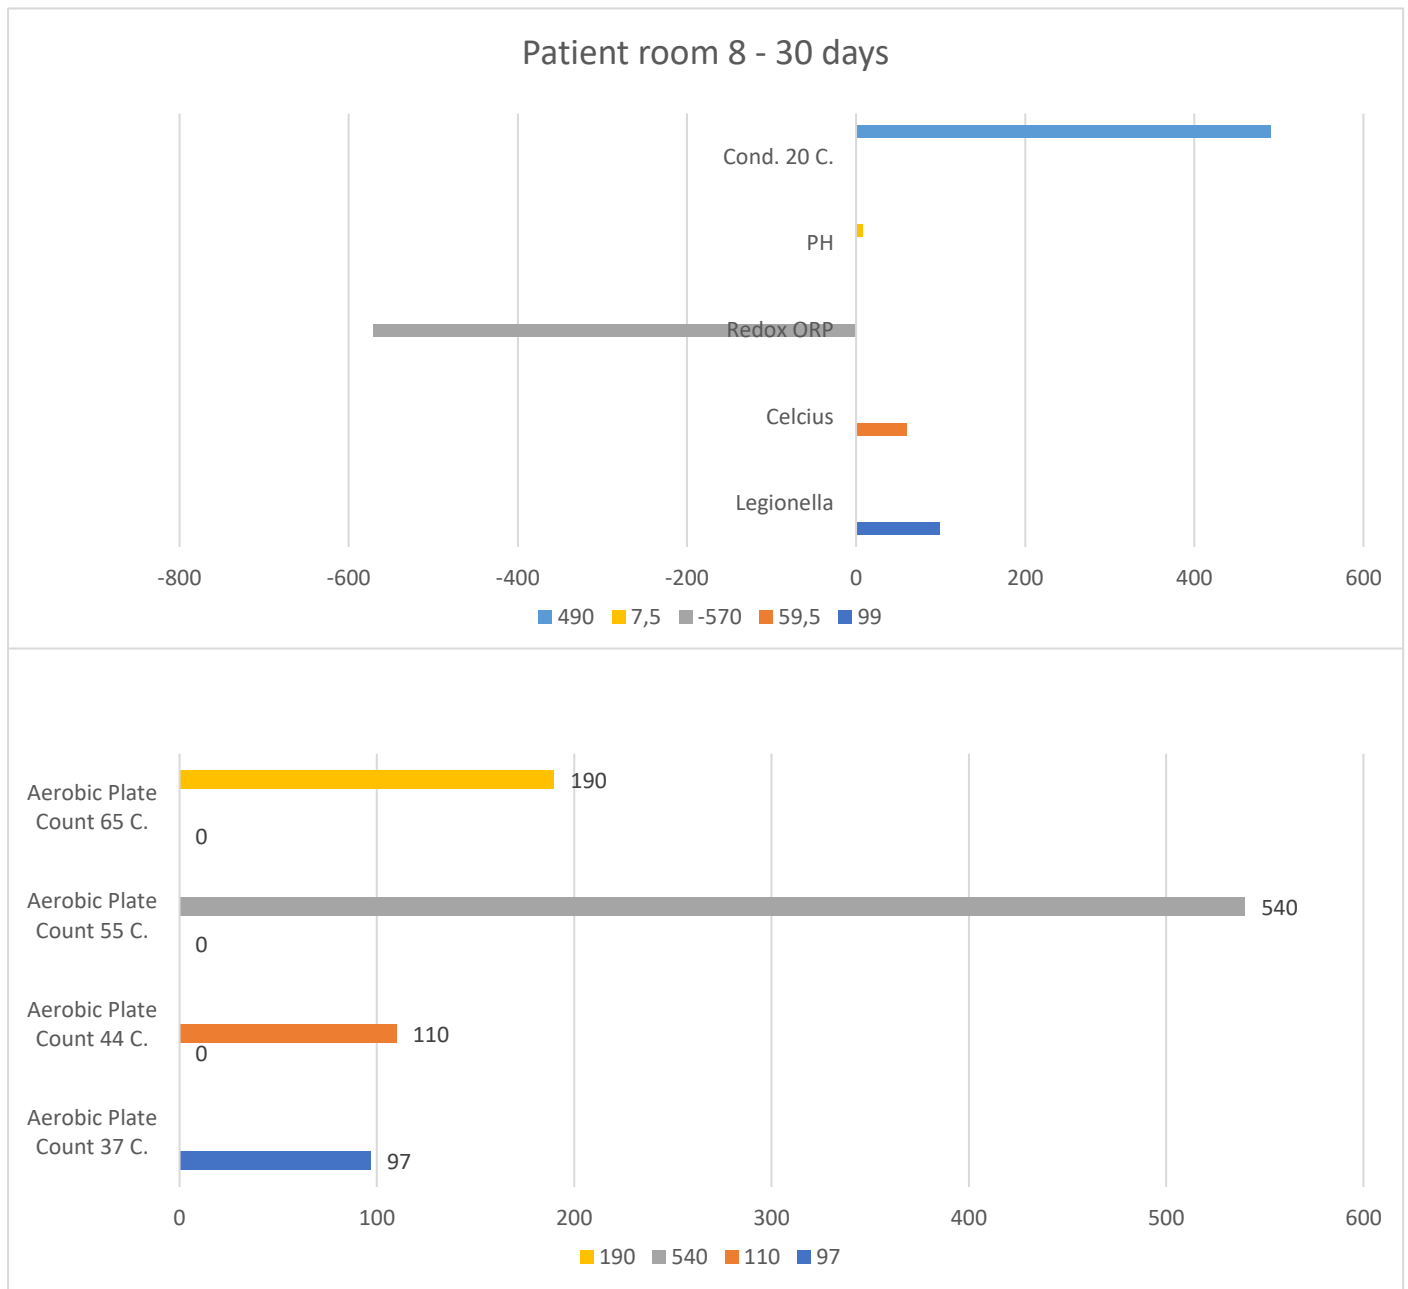
(Eurofin's Annex 4)

The first test, is from Patient Room 8 (30 days into the test period), i.e., halfway through

After the first 30 days midway through the test period, we can now see major changes in the water parameters.

The redox potential has increased from -184.9 to -570, which means that the water is more antioxidant.

There is a huge drop in the number of germs (Aerobic Plate Count), which means that bacteria no longer accumulate in the pipes.

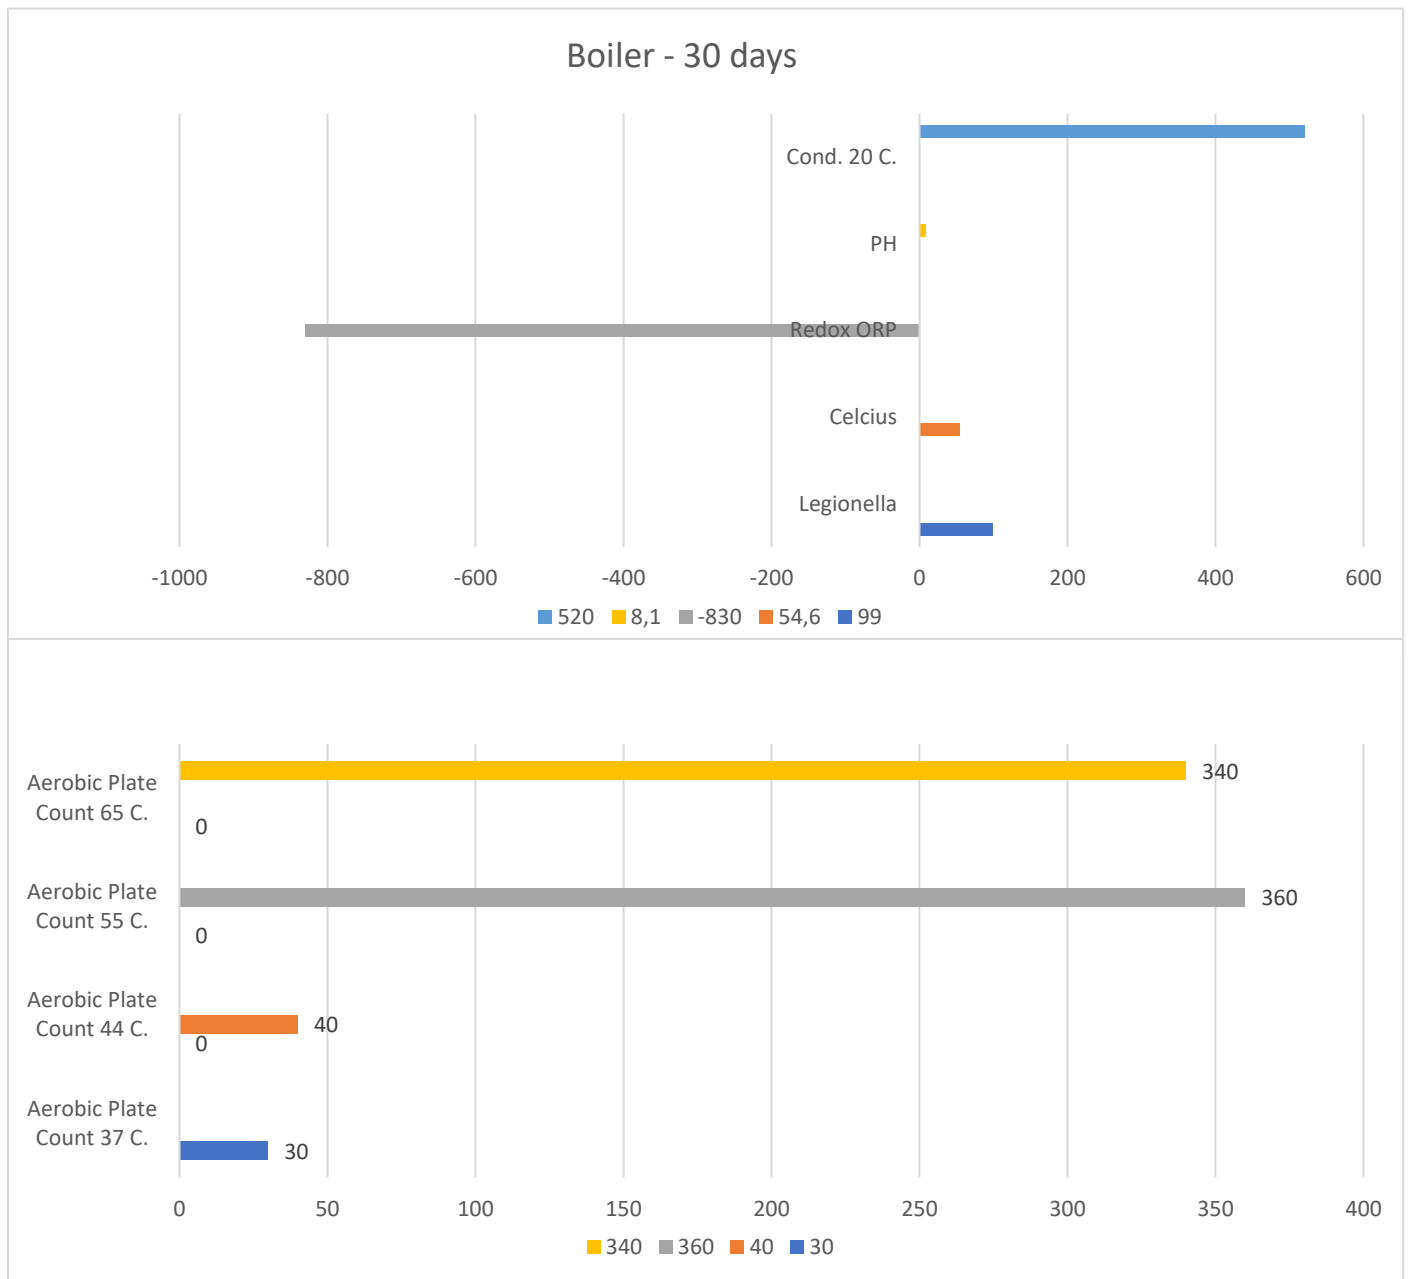
(Eurofin's Annex 5)

The last test, is from the hot water tank (30 days into the test period), i.e., halfway through

Here, the aerobic plate count is also reduced to almost nothing and no longer pose a problem for water quality.

Likewise, the Legionella number has fallen to below 100 from the first water analysis, where the Legionella number was 200.

Based on this observation, it can be established that when the aerobic plate count is reduced, i.e., the biofilm in the pipes, this also has an impact on the amount of Legionella present.

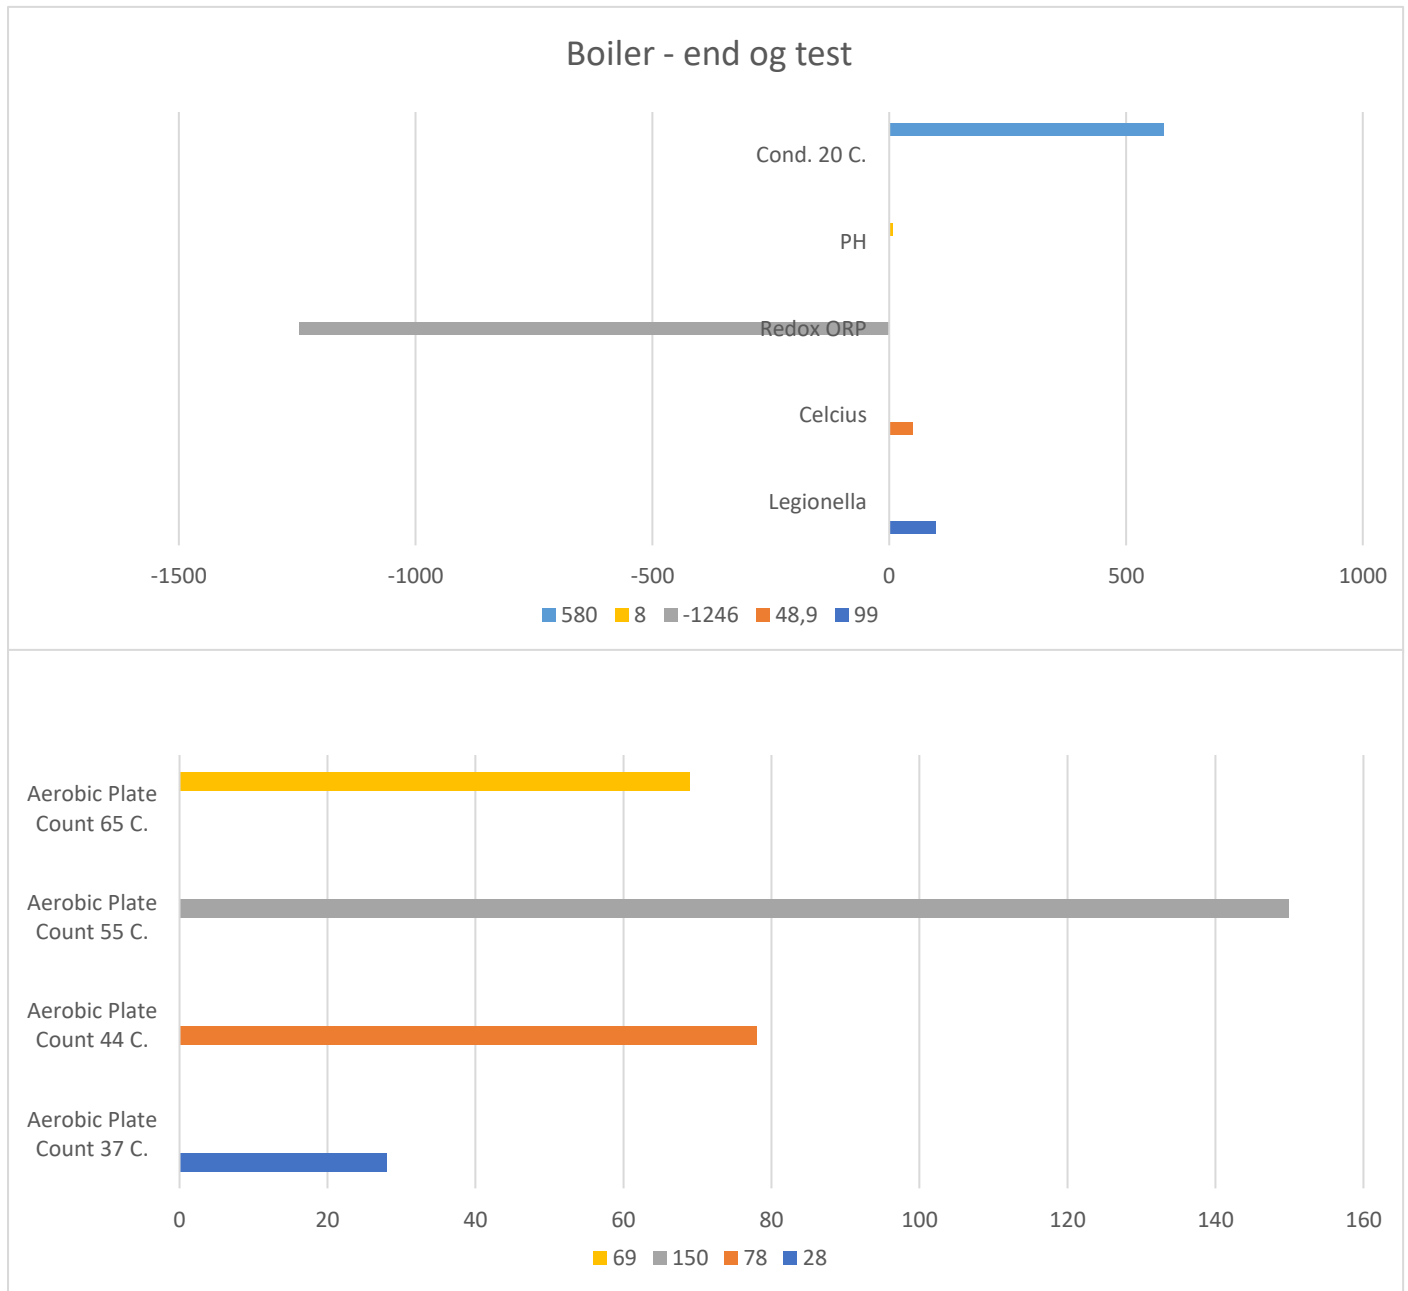
(Eurofin's Annex 7)

The second sample is from the hot water tank (60 days into the test period), i.e. end of the test period

The aerobic plate count (germ count) is still greatly reduced to almost nothing.

The redox potential has increased further from -830 to -1246, which again indicates that the water is more antioxidant.

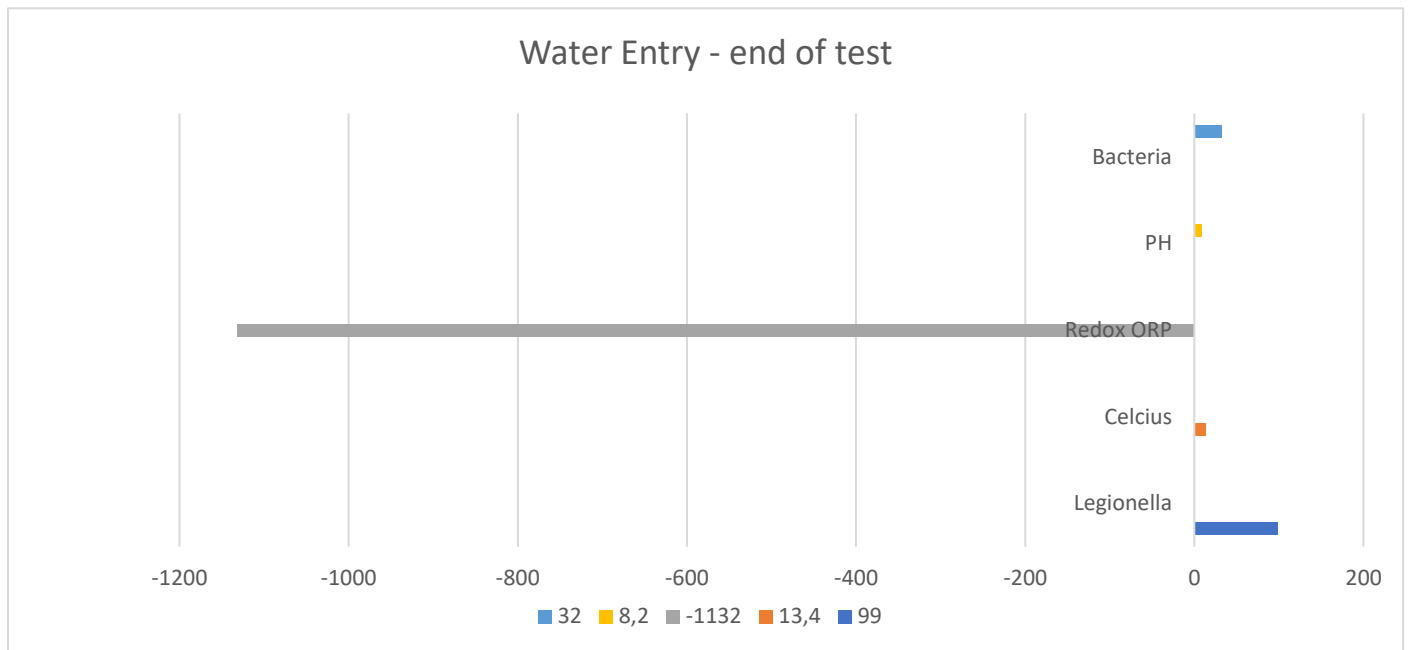
(Eurofin's Annex 8)

The last test is from the main water supply IN (60 days into the test period), i.e., End of the test period

The last water analysis carried out by Eurofins Denmark are on the main water supply (Entry water), as the test period is now ending. This is done to see if the BioEraser system has an influence already at this point when the water enters the house.

Since the BioEraser system is installed on the main water supply line right after the water meter, the limescale will be split and therefore no longer cause problems further in the installation, but you can also read from the water analysis that the redox potential has already at this point increased from -136.8 to -1132.

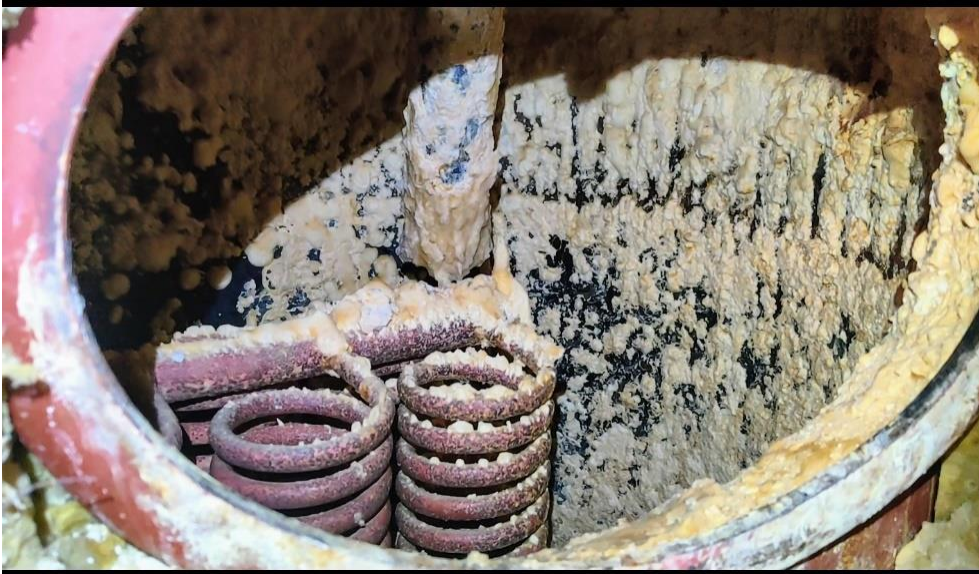
The picture below shows the inside of the hot water tank after 5 months with the BioEraser system installed

As can be seen in the pictures of the hot water tank, there have been no further significant lime deposits over the 5 months our BioEraser System has been installed. Which provides a considerable energy saving, since lime coatings on e.g., the heater acts as an insulator between the water to be heated and the heater itself.

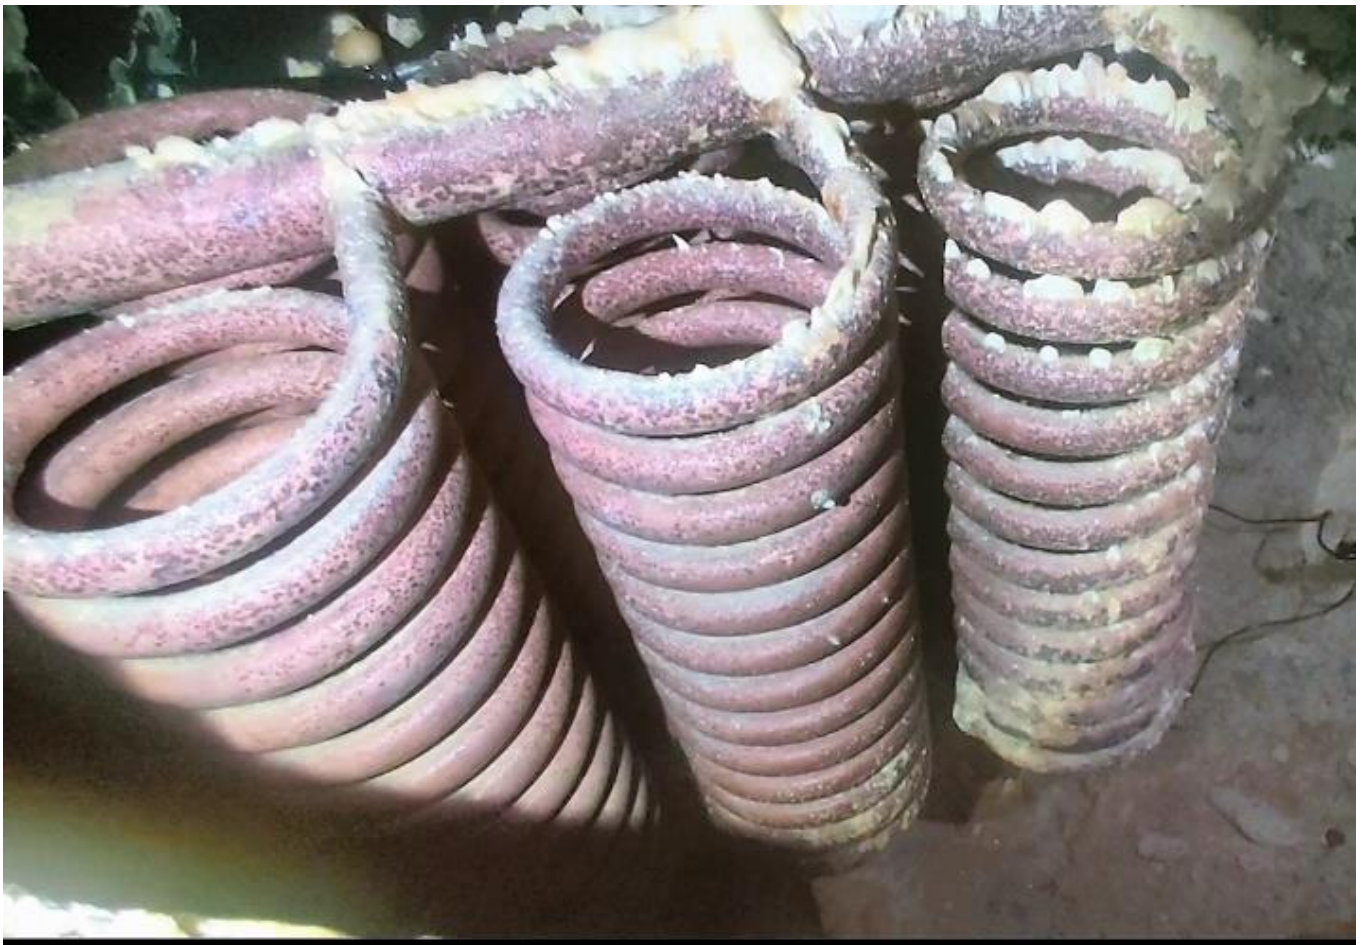
The image below shows the heater, and there are no additional lime coatings here either.
